4.9. HEALTH AND SAFETY AT THE RESTORATION WORKS OF THE ACROPOLIS MONUMENTS (GREECE)

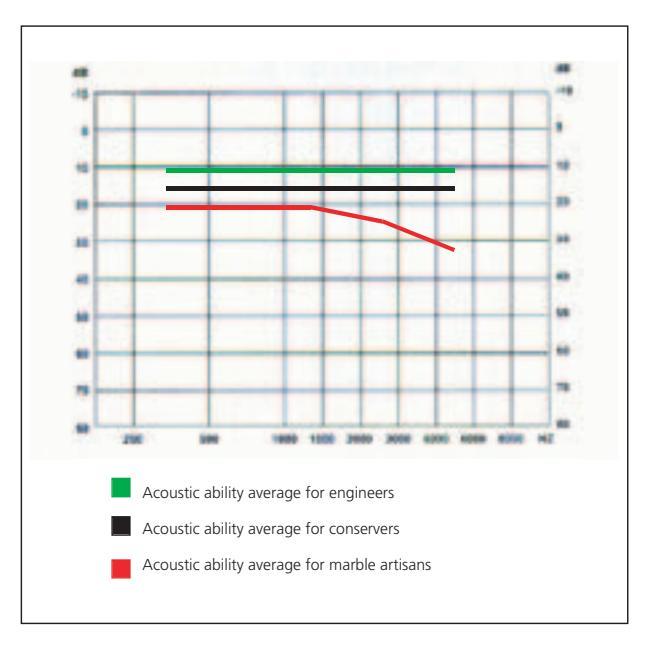
With regards to the medical examination those workers with significant reduction in their acoustic ability (proportional to years of exposure) were the marble artisans. In Figure 1 we can conclude that the group of marble artisans presents a significant reduction in acoustic ability in 2000 and 4000 Hz. The normal acoustic ability is around 0–10 dB.

Figure 1: Audiometry curves representing the acoustic ability of the groups of engineers, conservers and marble artisans
